Manhole Inspection Summary

Manhole # S41AA_006MH

Inspection ☐ Is Incomplete Rating: **3) Fair**

Location Address: **rear 723 n central ave**

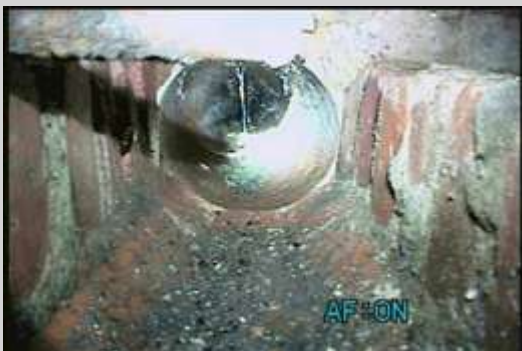
3 O'Clock Inflow

8 in. Circular Gravity Sewer
Pipe In @ 3 O'Clock

Pipe Material: **Clay** ☐ Pipe Lined

Invert Depth: 8.00 (ft.) Flow Characteristics: **None**

Deposits: ☒ **None** ☐ Mud ☐ Sludge ☐ Debris ☐ Grease

Infiltration: **None** Pipe Seal Cond: **Unknown**

Connects To: **House connection / Service line**

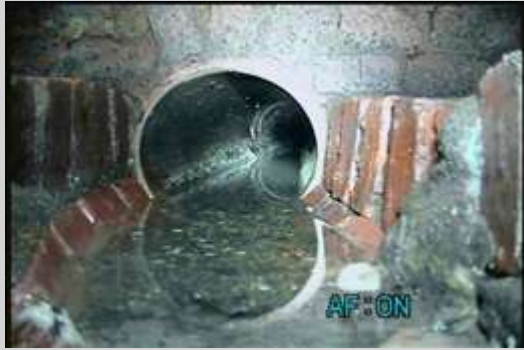
6 O'Clock Inflow

8 in. Circular Gravity Sewer
Pipe In @ 6 O'Clock

Pipe Material: **Clay** ☐ Pipe Lined

Infiltration: **None** Pipe Seal Cond: **Unknown**
